Learning Together

FEEDBACK FROM NEONATAL CLINICAL INCIDENTS

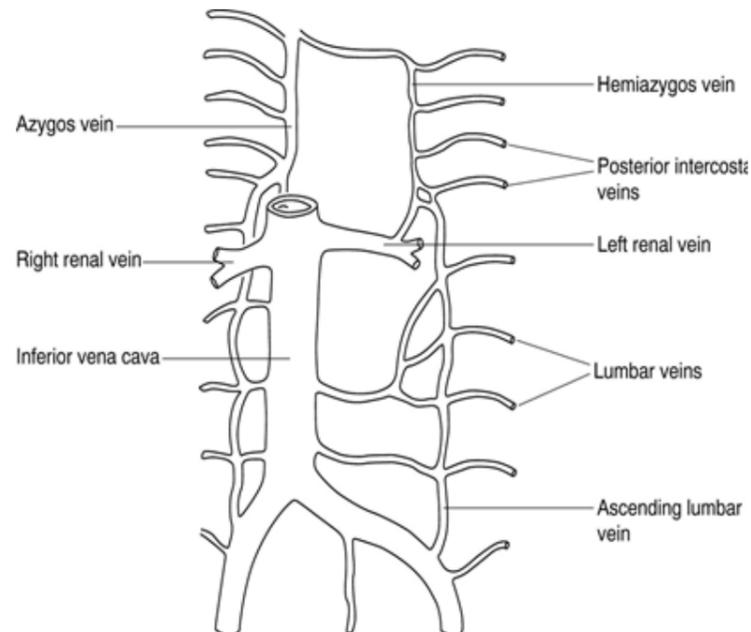
Image 1
Anatomy of left ascending lumbar vein

- These cases highlight a very rare complication of lower limb PICC line insertion
- A PICC line inserted in the left long saphenous vein can enter the left ascending lumbar vein (which runs posterior and parallel to the IVC, image 1) and can then enter the epidural plexus which are small thin walled veins. If vein perforation occurs, fluid from the PICC can enter the CSF and cause neurological damage

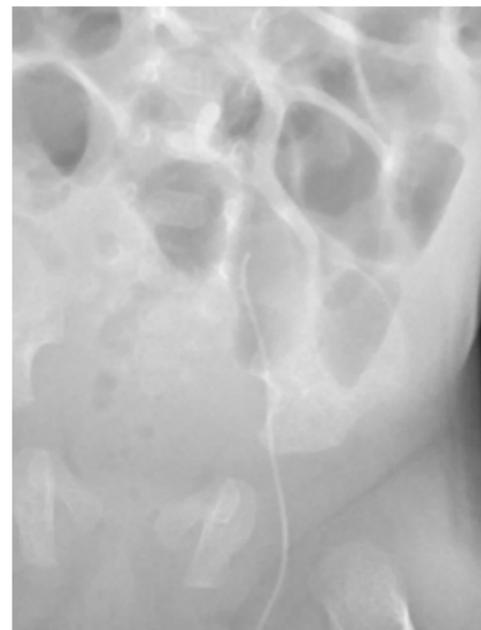
Image 2
A malpositioned PICC line which has not crossed the midline and remains on the left side of the vertebral column

- On AP x-ray to check line position a left saphenous PICC should track from the leg into the abdomen via the left iliac vein. It should cross the midline at L_{4/5} to run on the RIGHT side of the vertebral column in the IVC
- There should be no tortuosity in the path of the PICC line (tortuosity could be a sign it is in a small vessel)
- If a left lower limb PICC does not cross the midline as expected (image 2) or has a tortuous course (image 3), consider a lateral X-ray and discussion with radiology
- In the case of PICC malposition a lateral x-ray will demonstrate posterior deviation of the line towards the vertebral column (image 4)

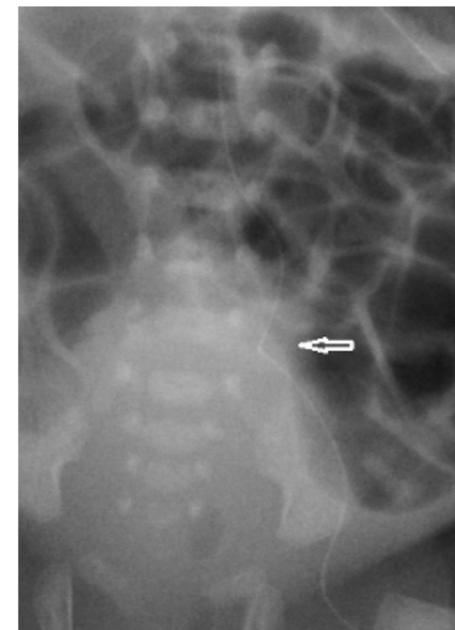
Image 3
A PICC line showing a tortuous course (arrow) and not crossing the midline to run on the right side of the vertebral column

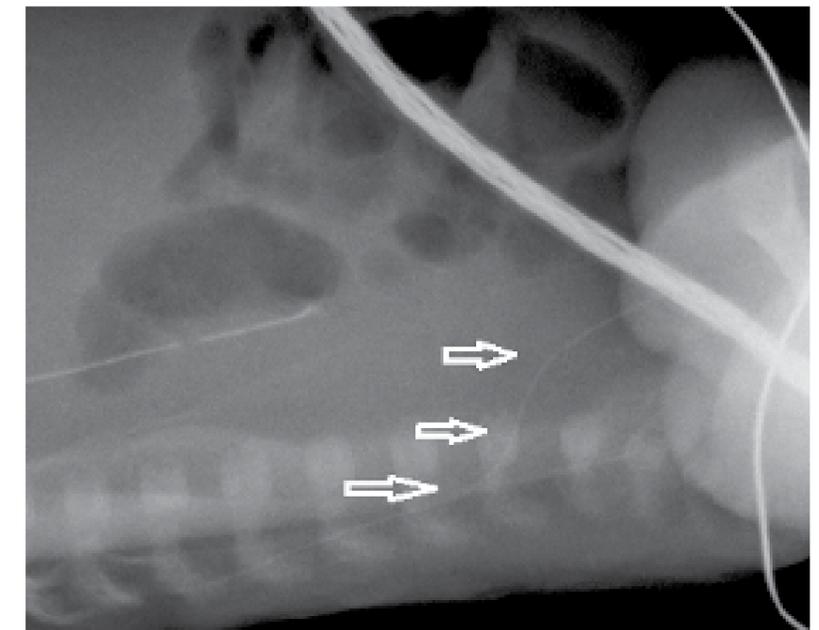
Image 4
A lateral x-ray demonstrating posterior deviation (arrows) of the PICC line towards the vertebral column
